**HAZARDOUS BUILDING MATERIALS
SURVEY REPORT
SAN JOSE CORPORATION YARD
696 NORTH SIXTH STREET
SAN JOSE, CALIFORNIA**

PREPARED FOR: San Jose Redevelopment Agency
200 East Santa Clara Street, 14th Floor
San Jose, California 95113

October 8, 2007

File No.: 86782/PW-SVY
October 8, 2007

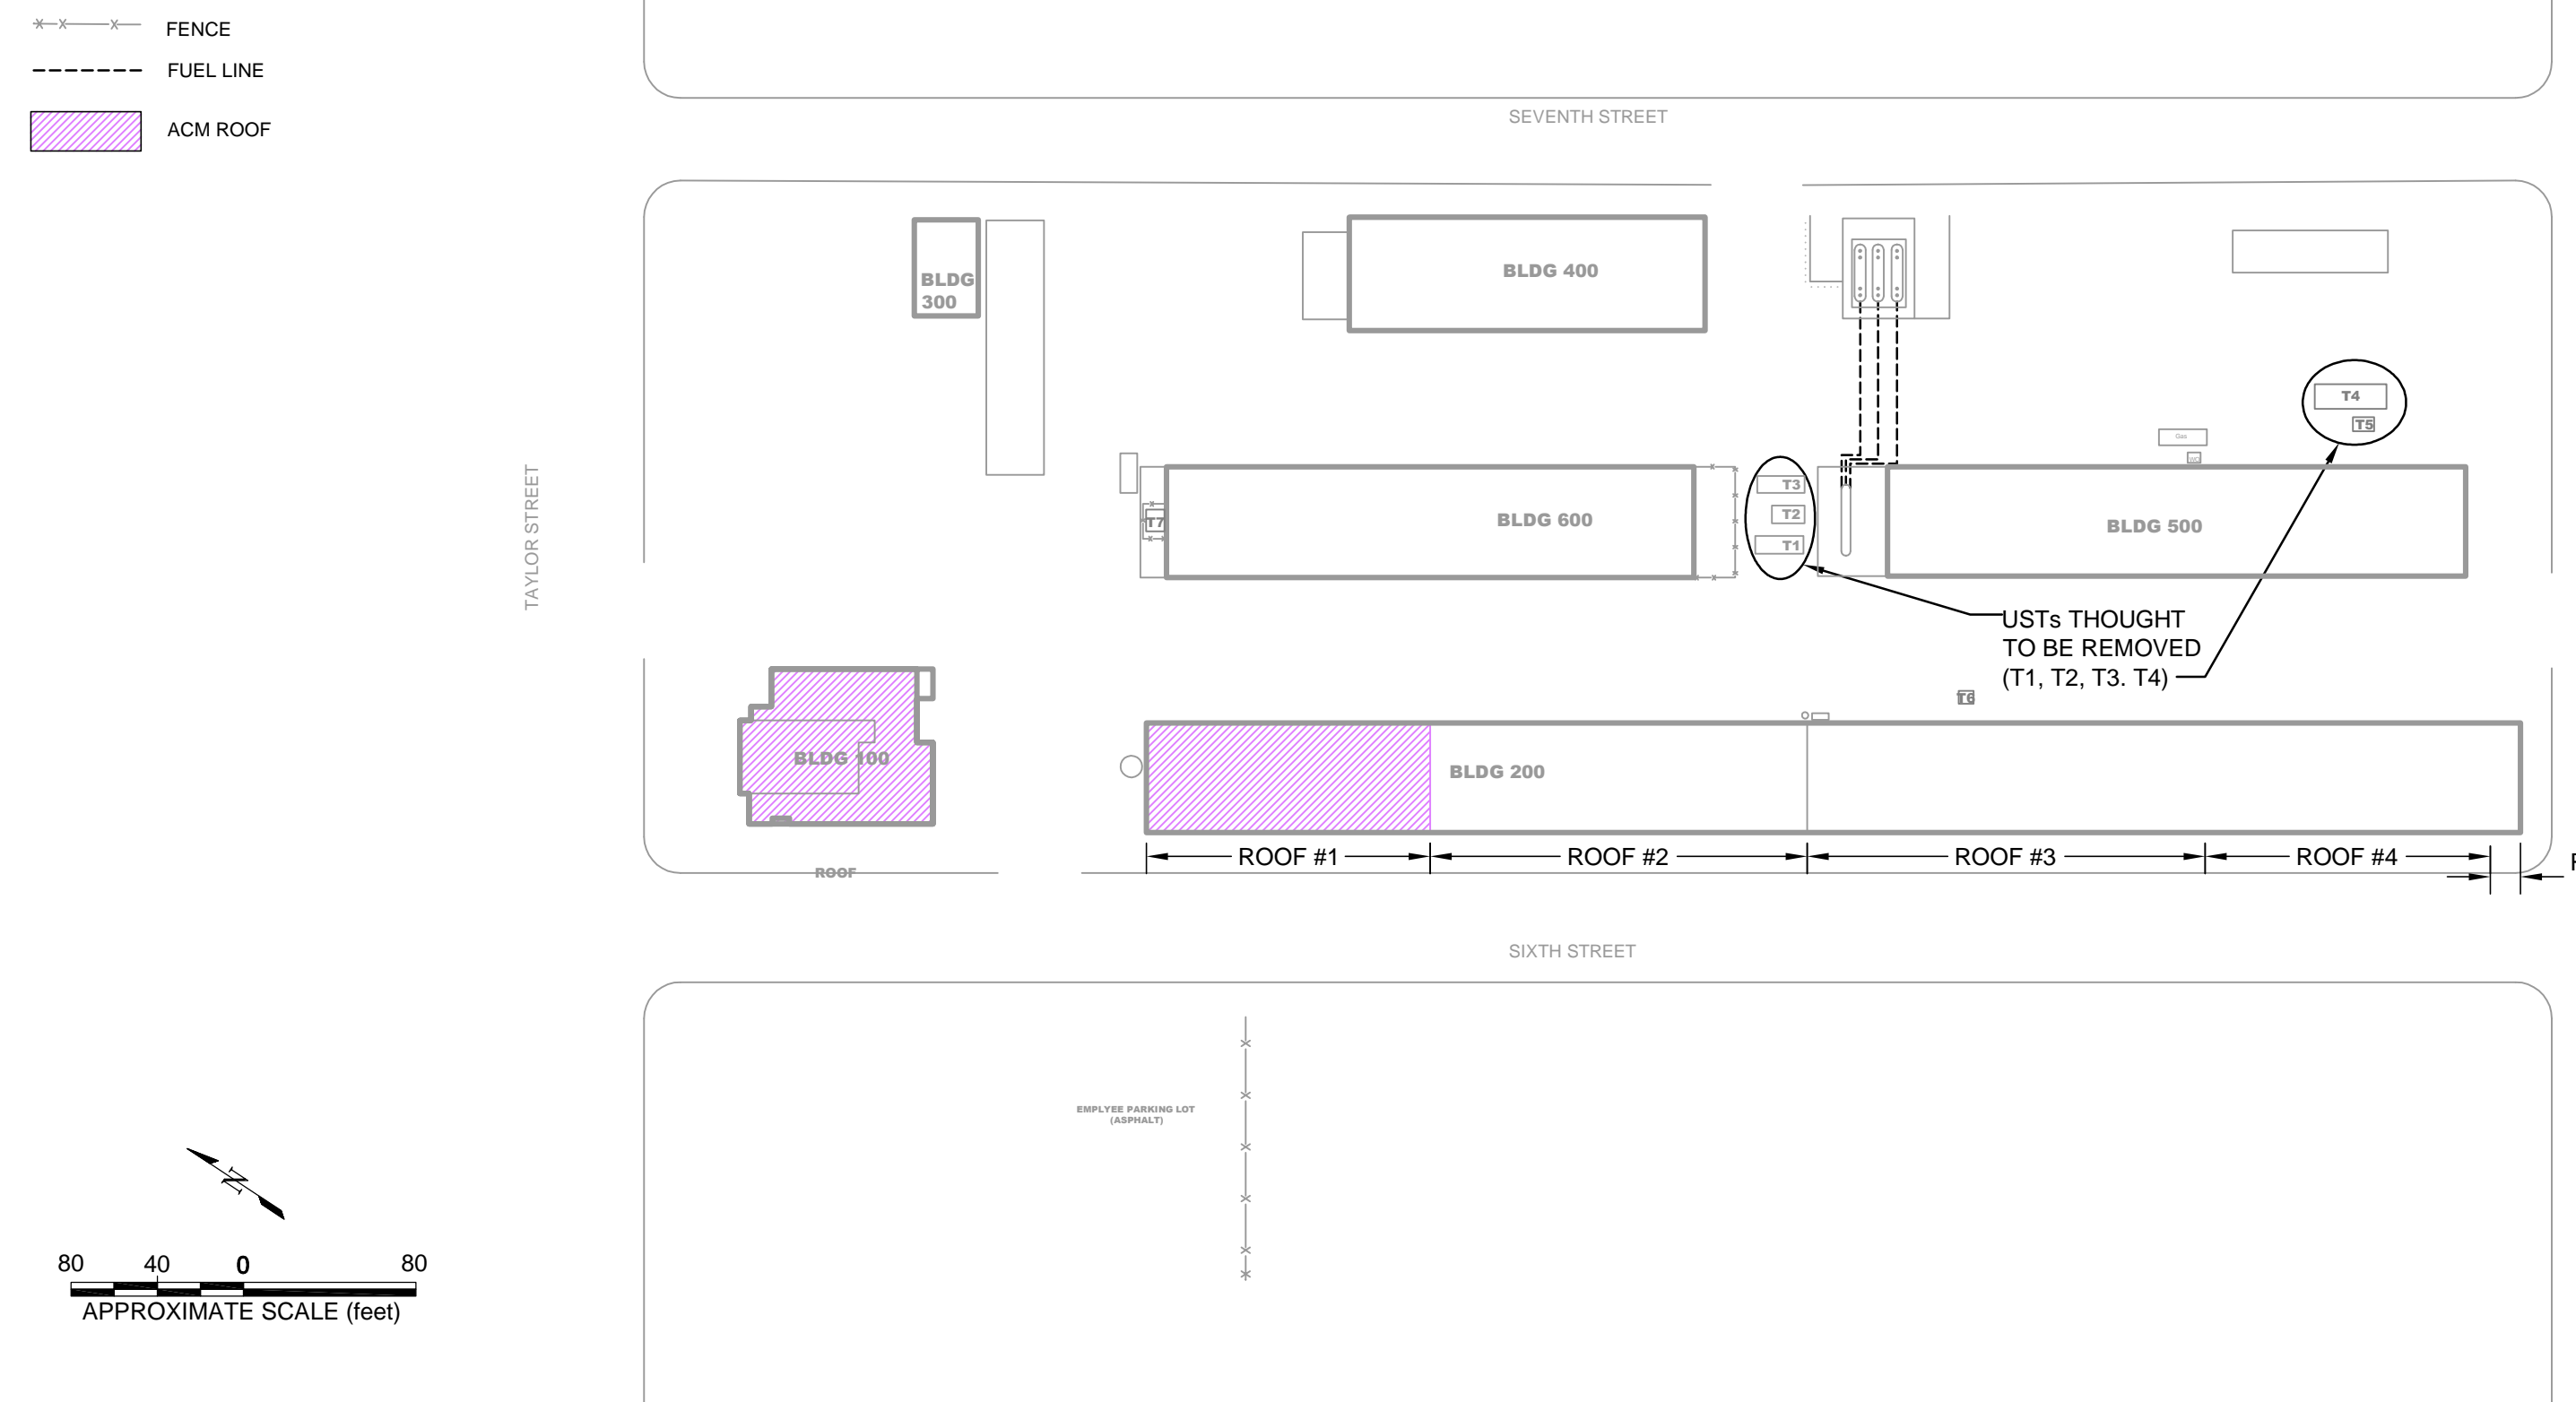
- 8,000 square feet of white rock asphalt roofing and 3 layers of roofing felt each with 60% asbestos content under a thin coat of silver paint containing 2% asbestos content. In addition, 400 square feet of black/gray mastic, used to seal the asphalt roofing at the top of the Roof #1 perimeter parapet, was reported by the laboratory to contain 5% asbestos. These materials were only found in the northern most roof section (original building) referred to in this report as Roof #1. Roof sections identified as Roofs #2, #3, #4, and #5 were composed of non-ACM asphalt and black felt roofing materials;
